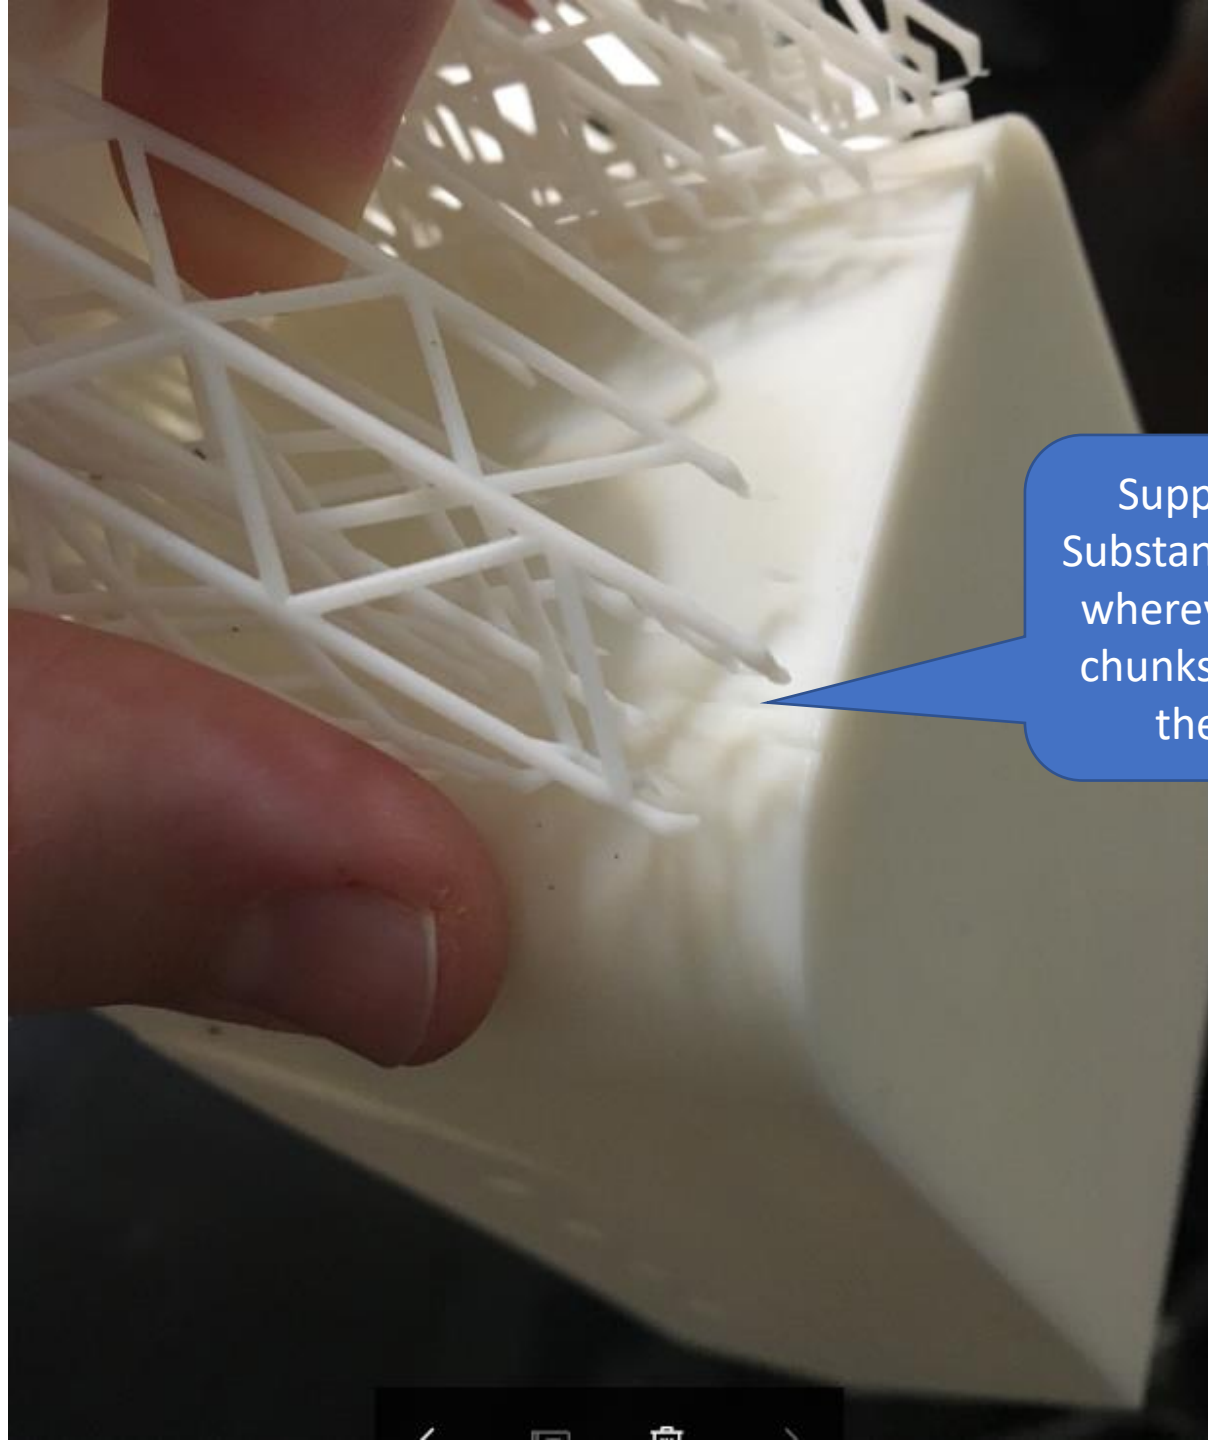
Supports are separated from the part. Substantially large pitting is seen in the part wherever the supports were. You can see chunks of material pulled from the part at the end of the detached supports.

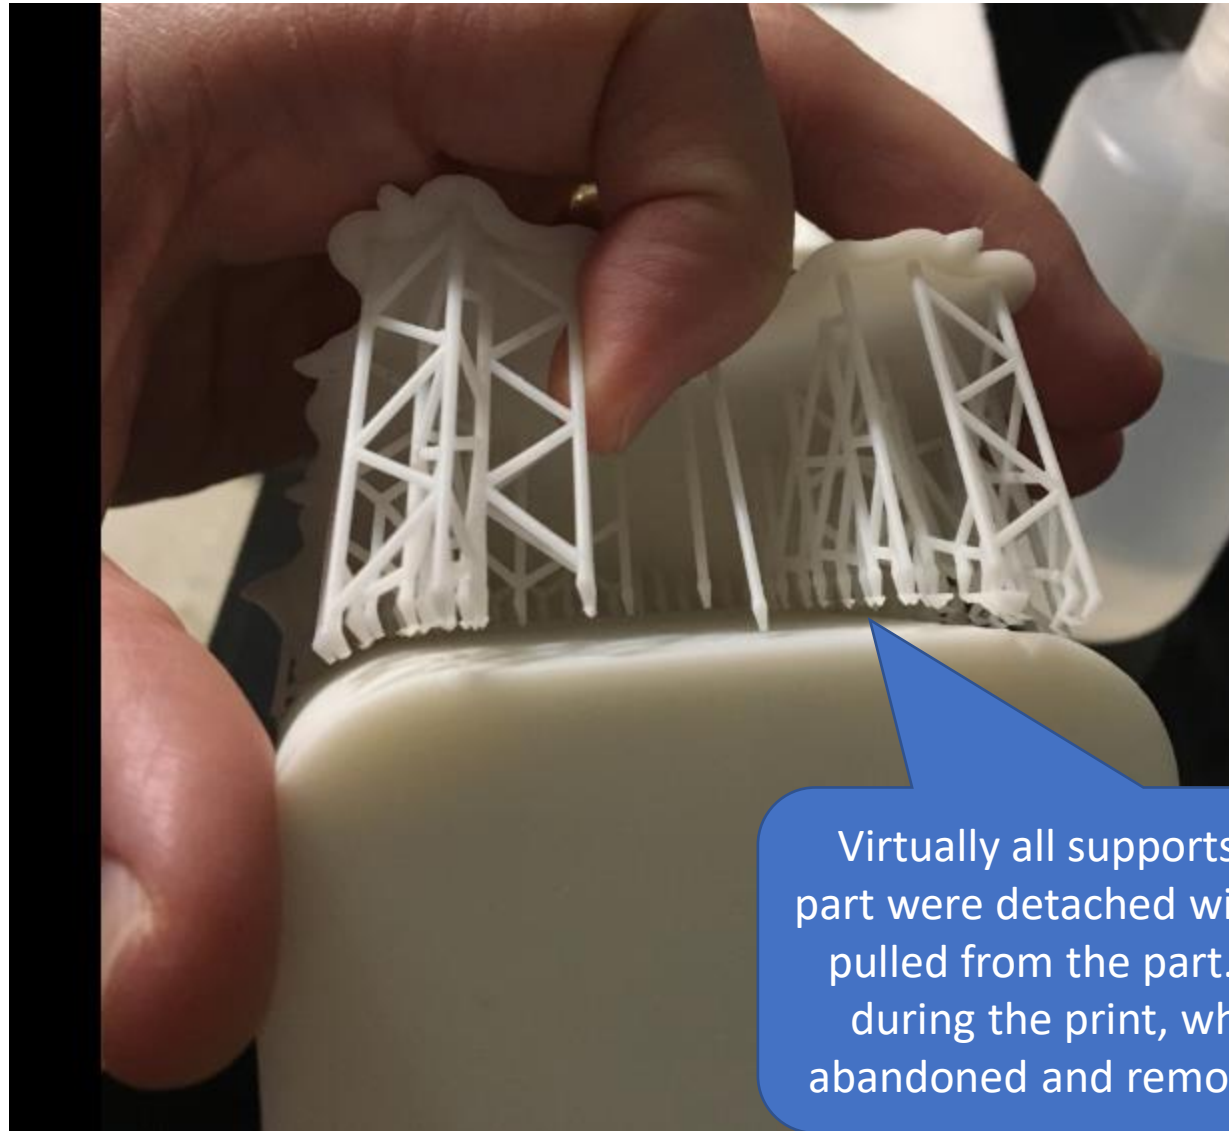
Virtually all supports on one side of the part were detached with chunks of material pulled from the part. This was observed during the print, which I subsequently abandoned and removed from the printer.

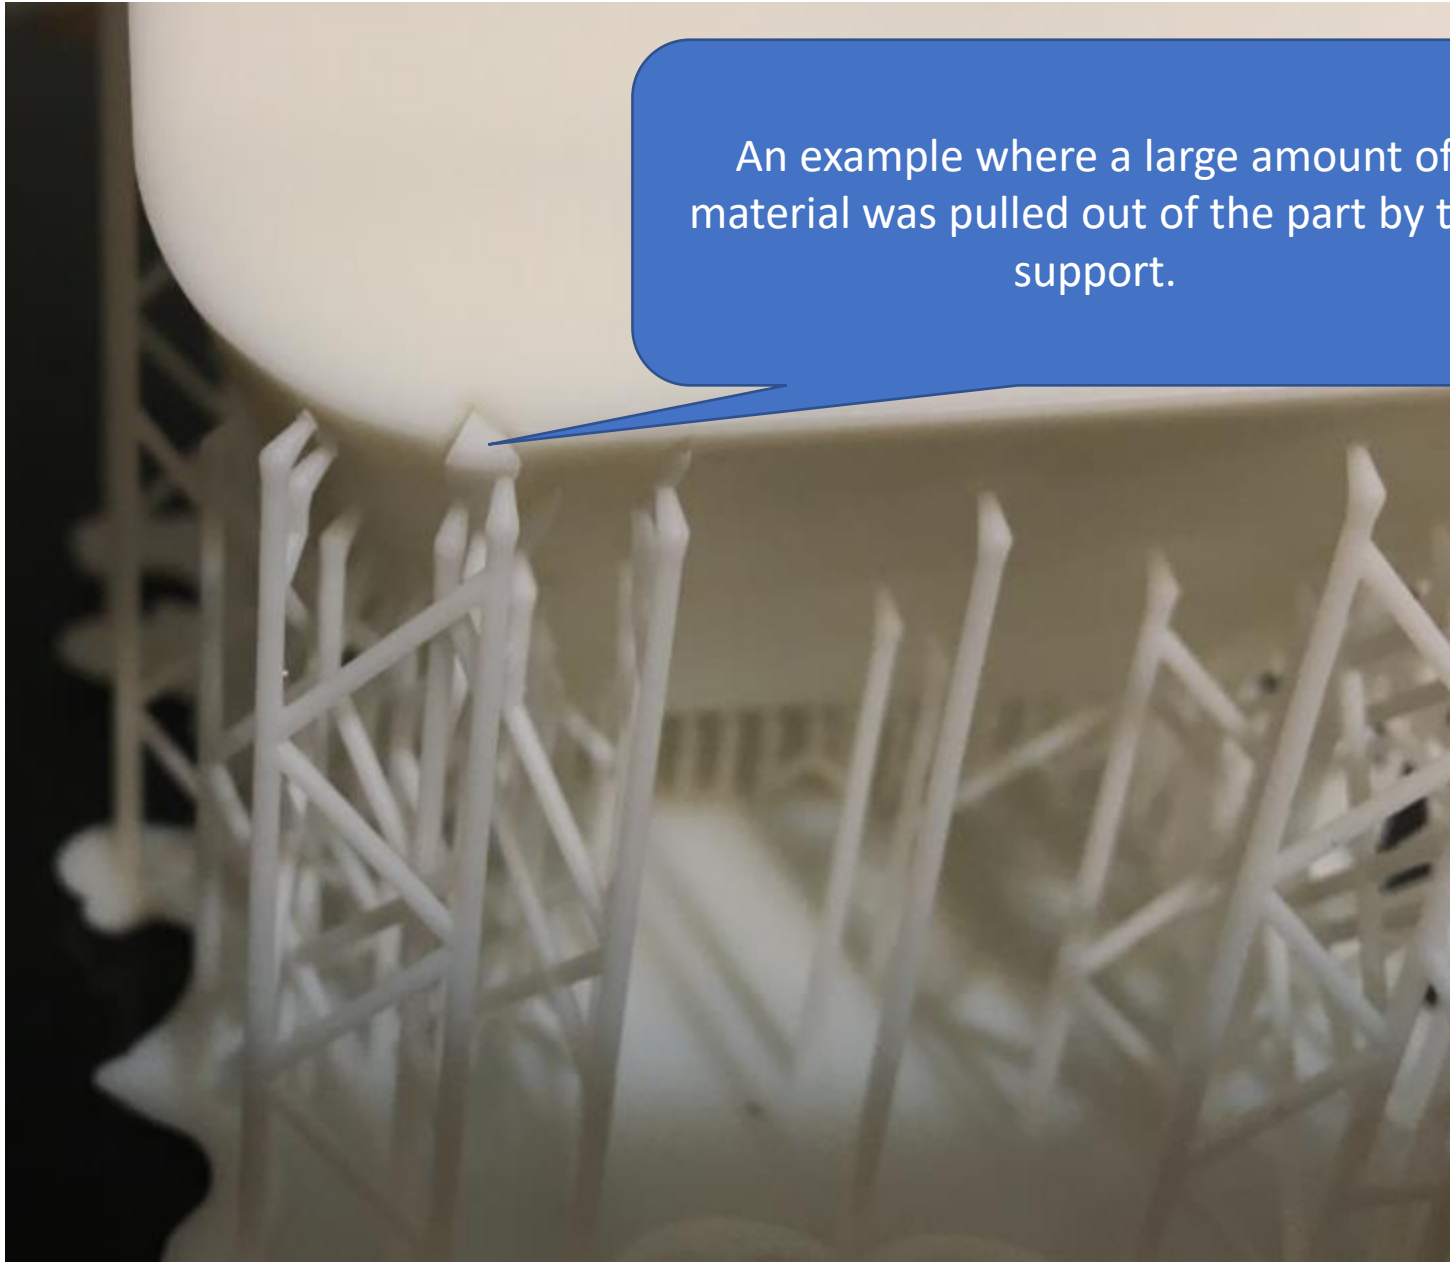
An example where a large amount of material was pulled out of the part by the support.

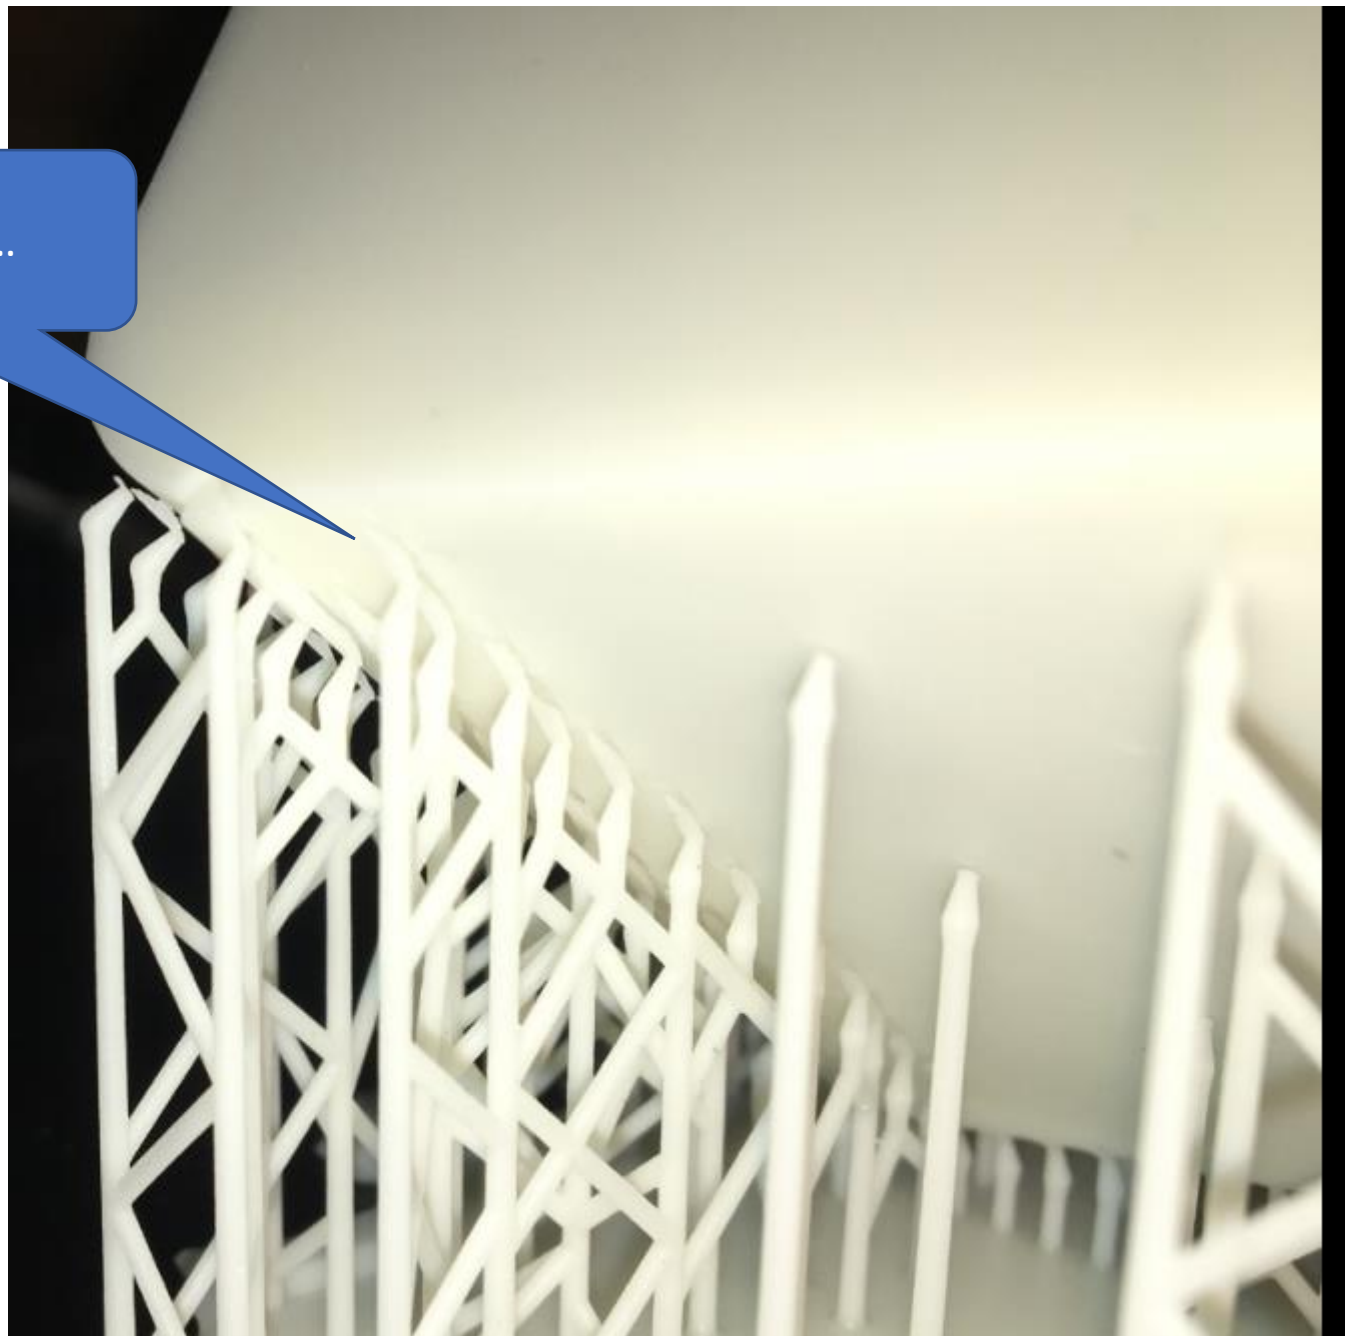
More examples...

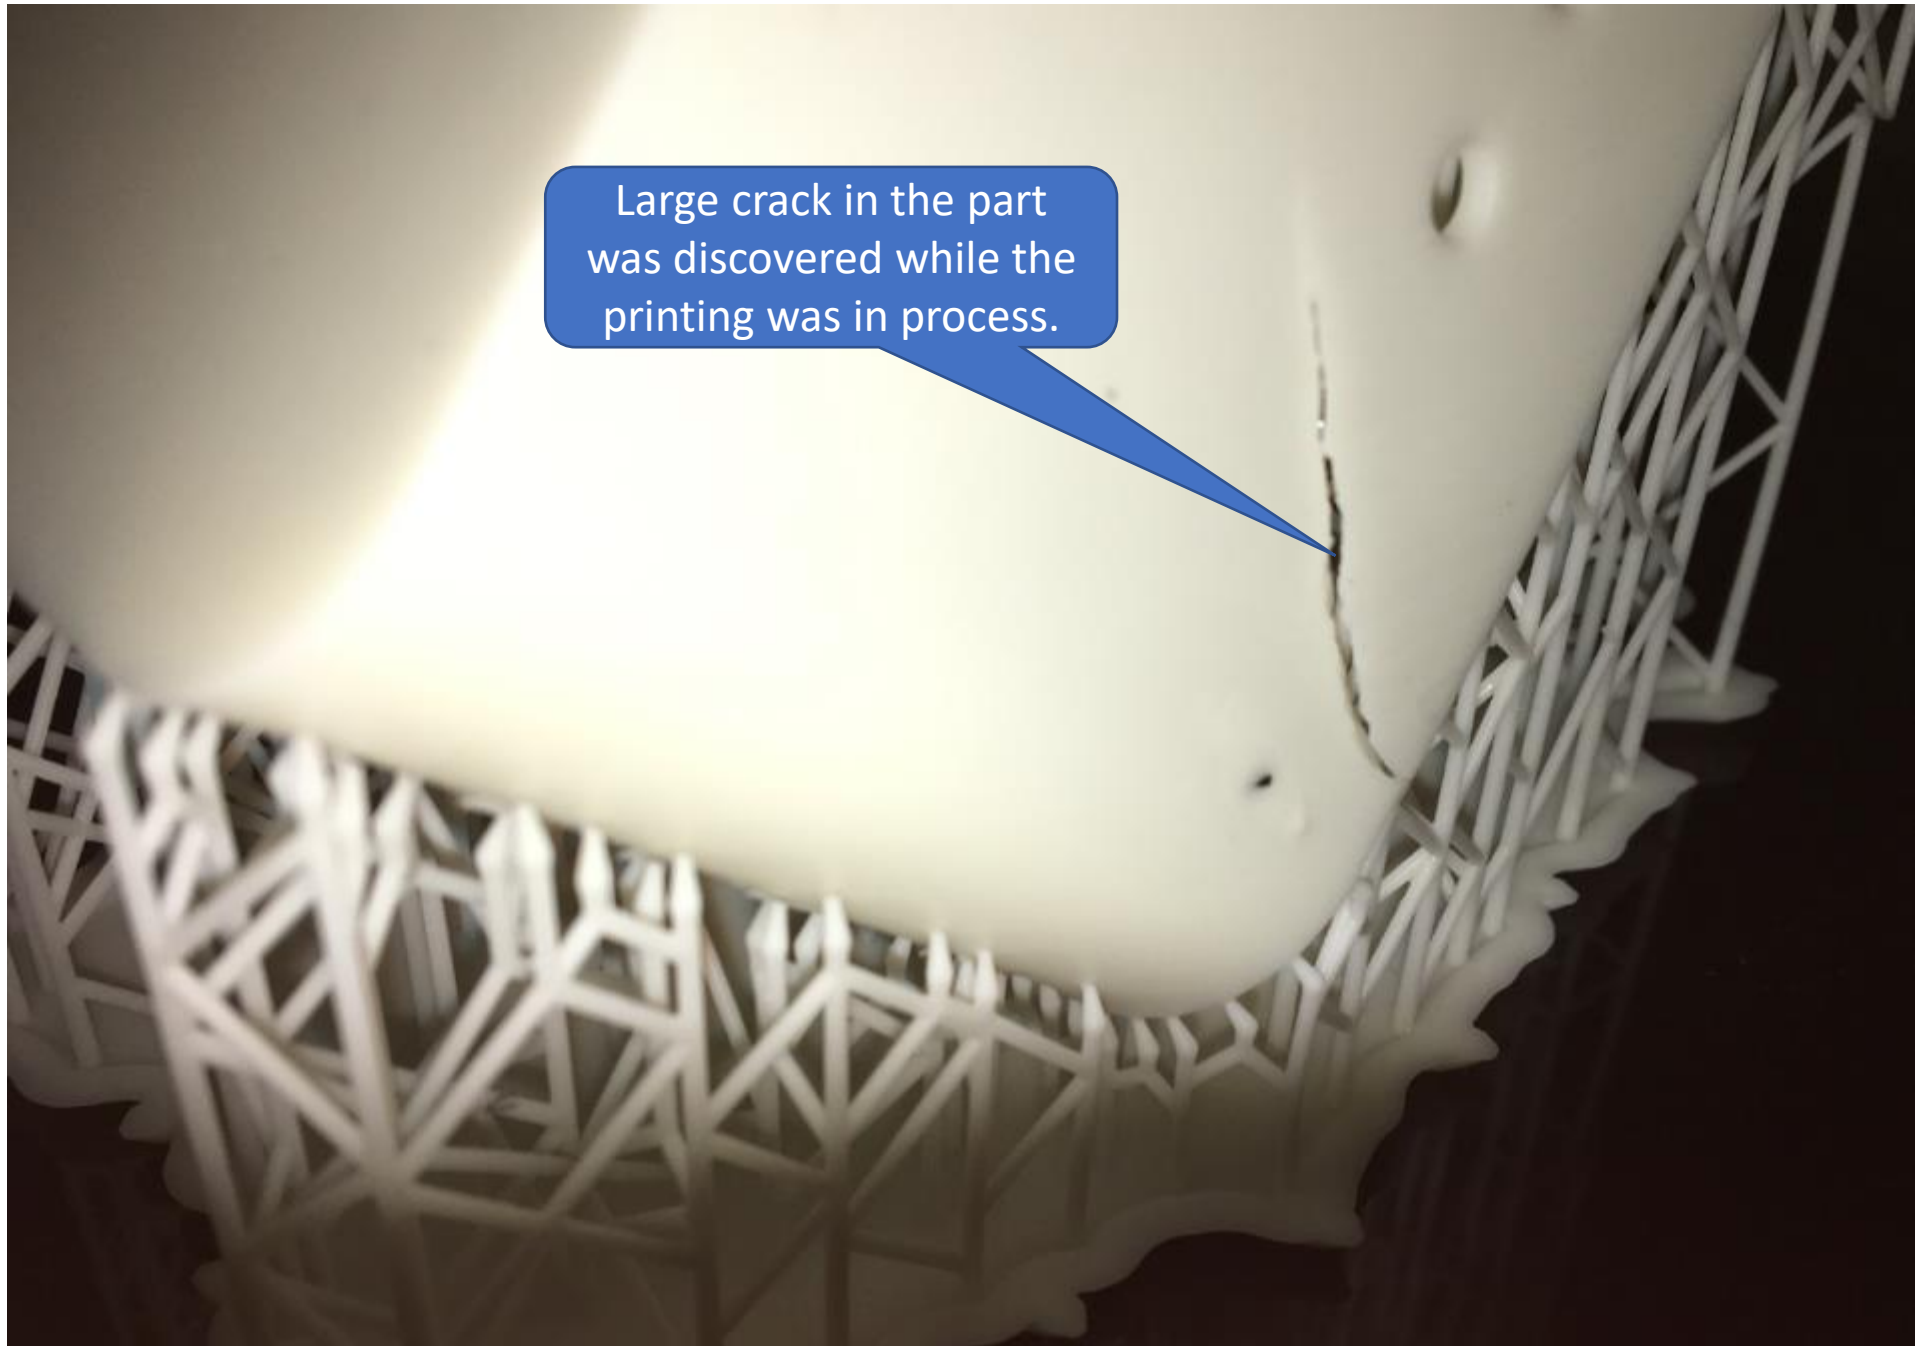
Large crack in the part
was discovered while the
printing was in process.
